NRL Memorandum Report 1457

FRACTOGRAPHY
PART XV. SOME ARTIFACTS POSSIBLE WITH
THE TWO-STAGE PLASTIC CARBON REPLICATION TECHNIQUE

E. P. Dahlberg and C. D. Beachem

METALLURGY DIVISION

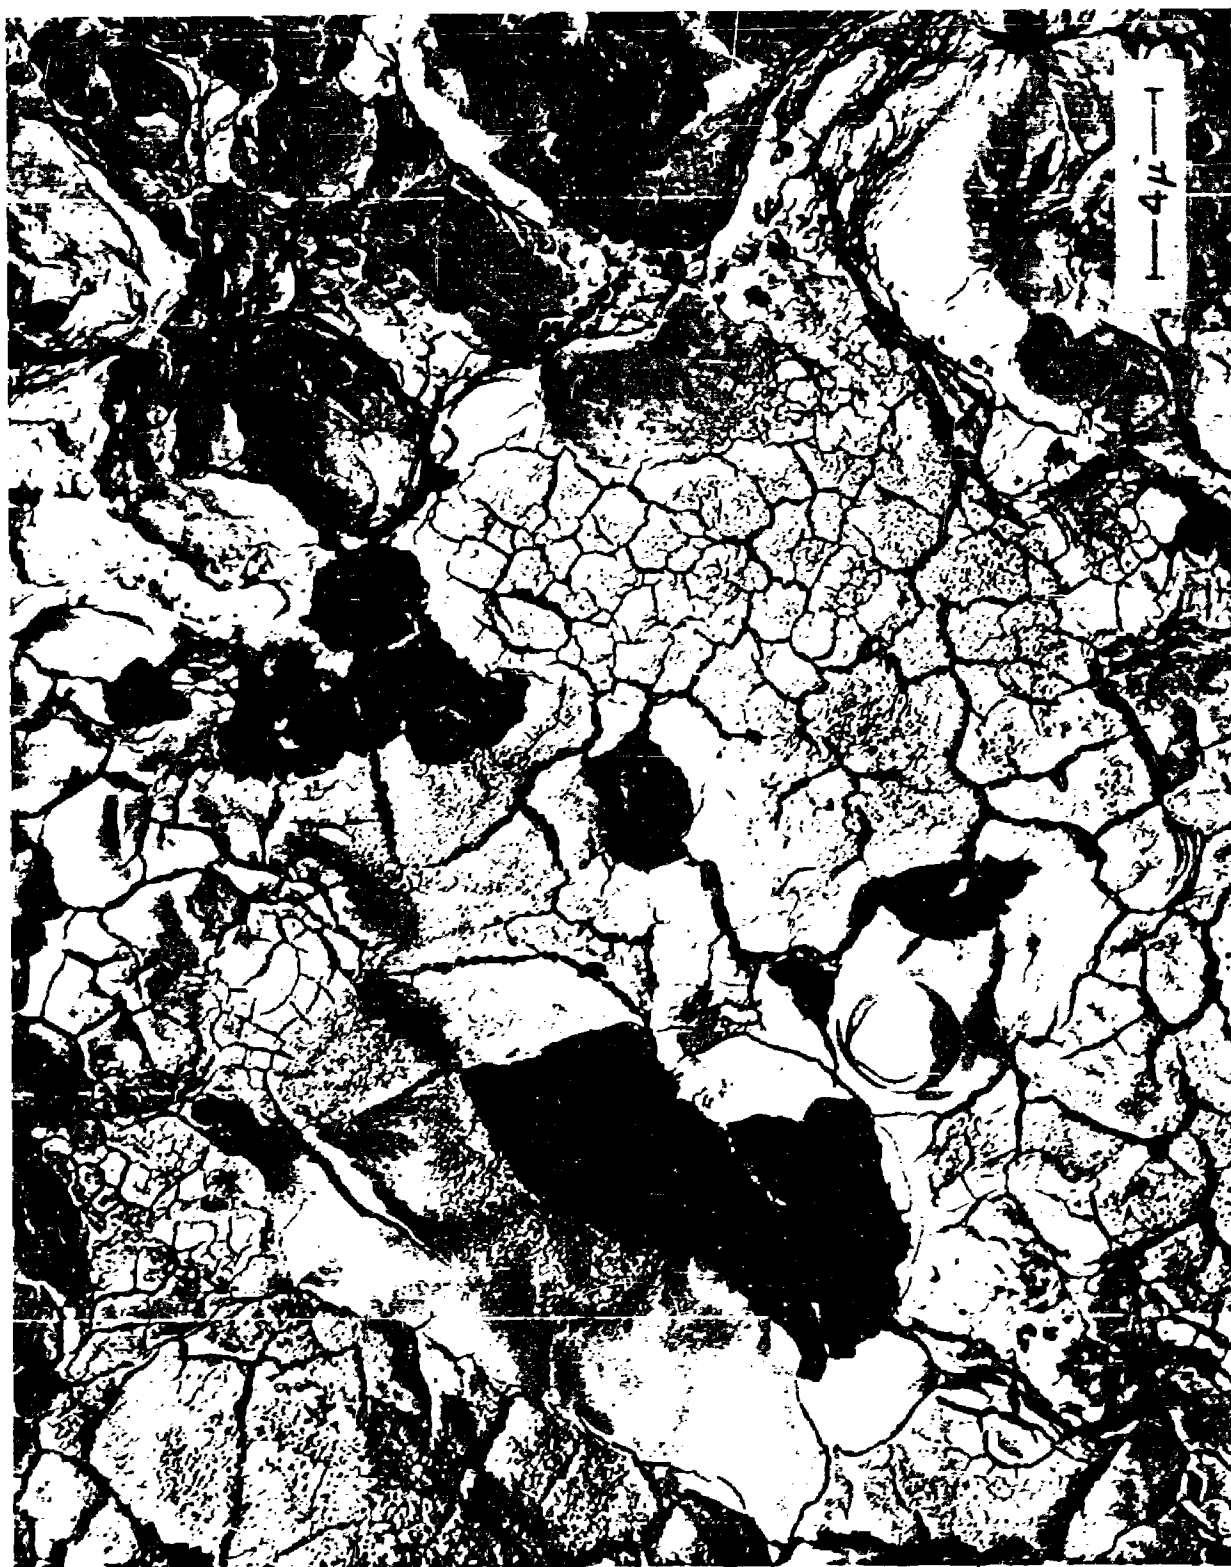
Fig. 1 - Characteristic appearance of a rust formation on
a fracture of mild steel

If the maximum information is to be obtained from electron microscope observations the fractures must be replicated in a "clean" condition. Since the details of interest are of a very fine scale they can easily be obliterated by "after the fact" corrosion and handling. The presence of any dirt, rust, or other foreign matter on the fracture surface will greatly hamper the microscopic observations. Figure 1 shows the characteristic feature associated with the presence of rust on fractures of ferrous materials. The several large black areas are portions of the rust deposit which were lifted off the fracture surface by the initial plastic replica. The surface structure of the rust deposit which remained attached to the fracture is exhibited in the surrounding regions. The layer of rust appears to break into several small fragments. Replicas of the surface cracks around each of these small fragments produces the polygonized structure evident in the fractograph.

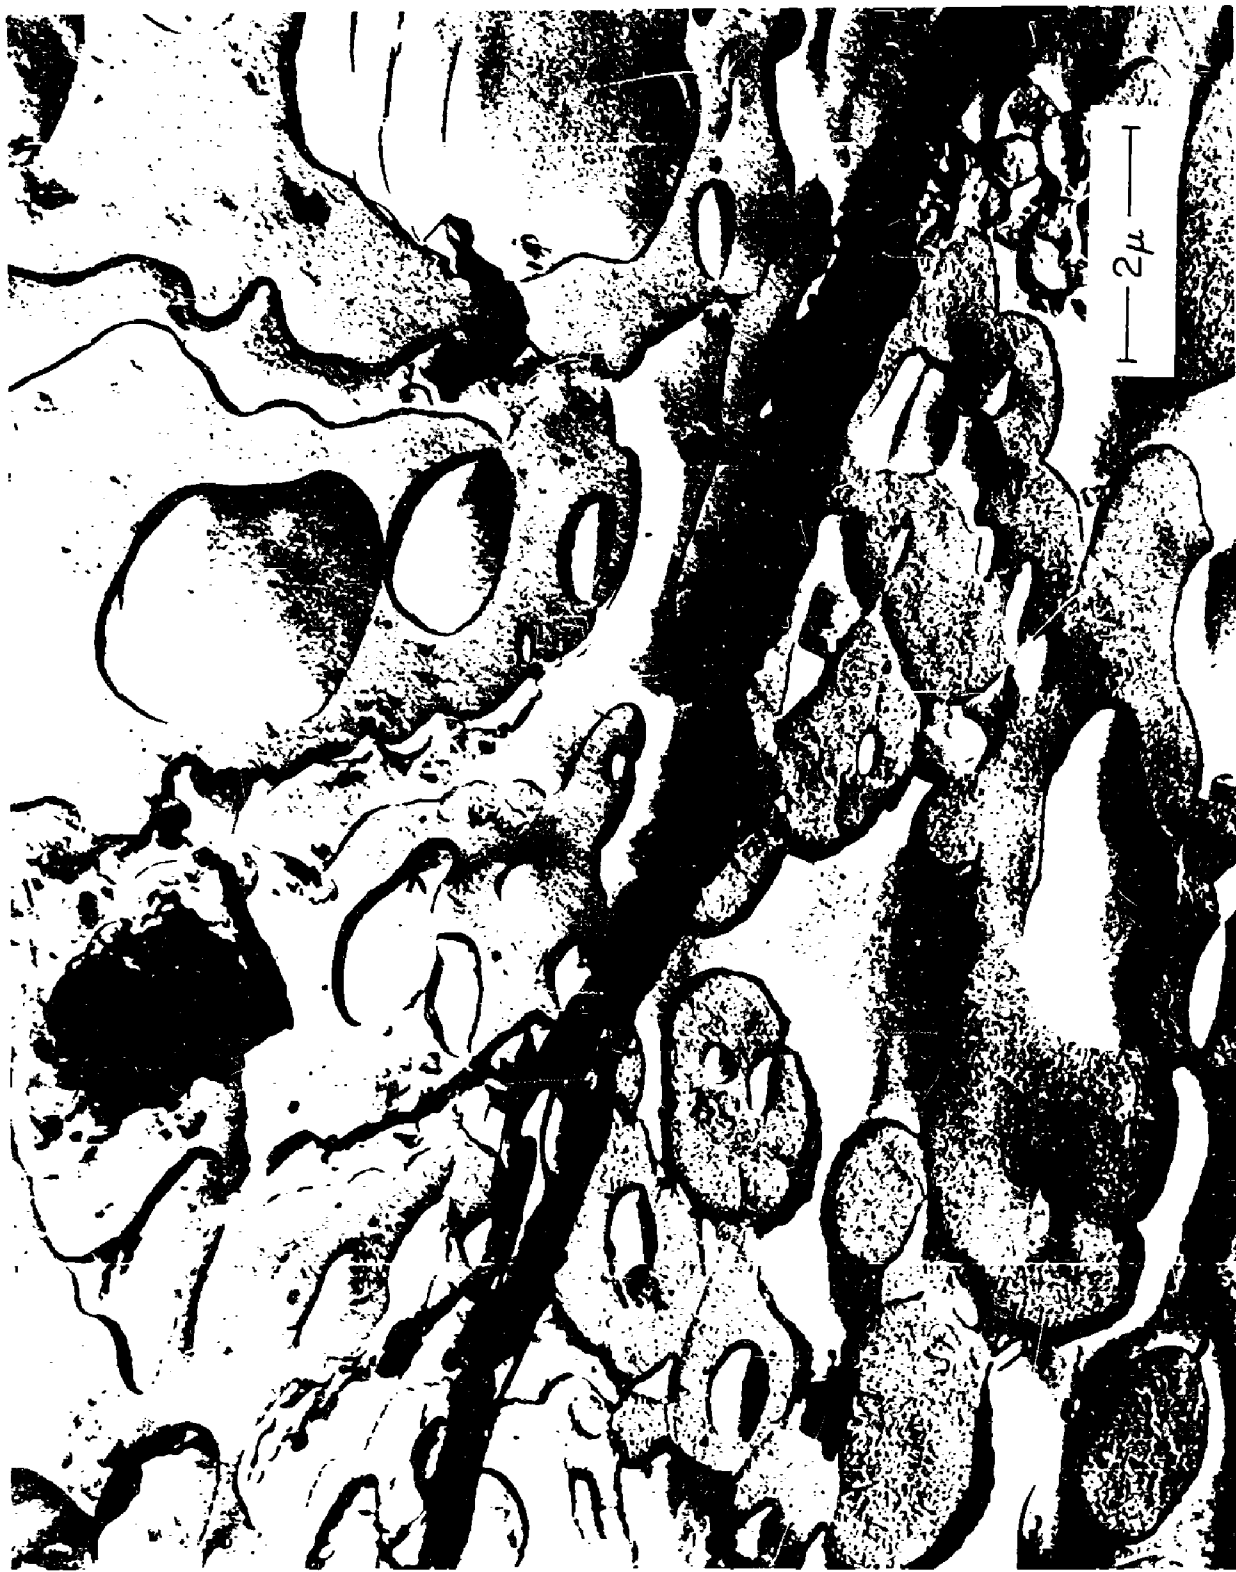
Fig. 2 - Improperly cleaned fracture surface showing drops
of liquid which was not removed prior to replication

Figure 2 shows an artifact which resulted when a liquid rust preventative (immiscible in acetone) was not completely removed from a fracture prior to replication. The bubble-like structure resulted from replicating the liquid which remained on the fracture surface.

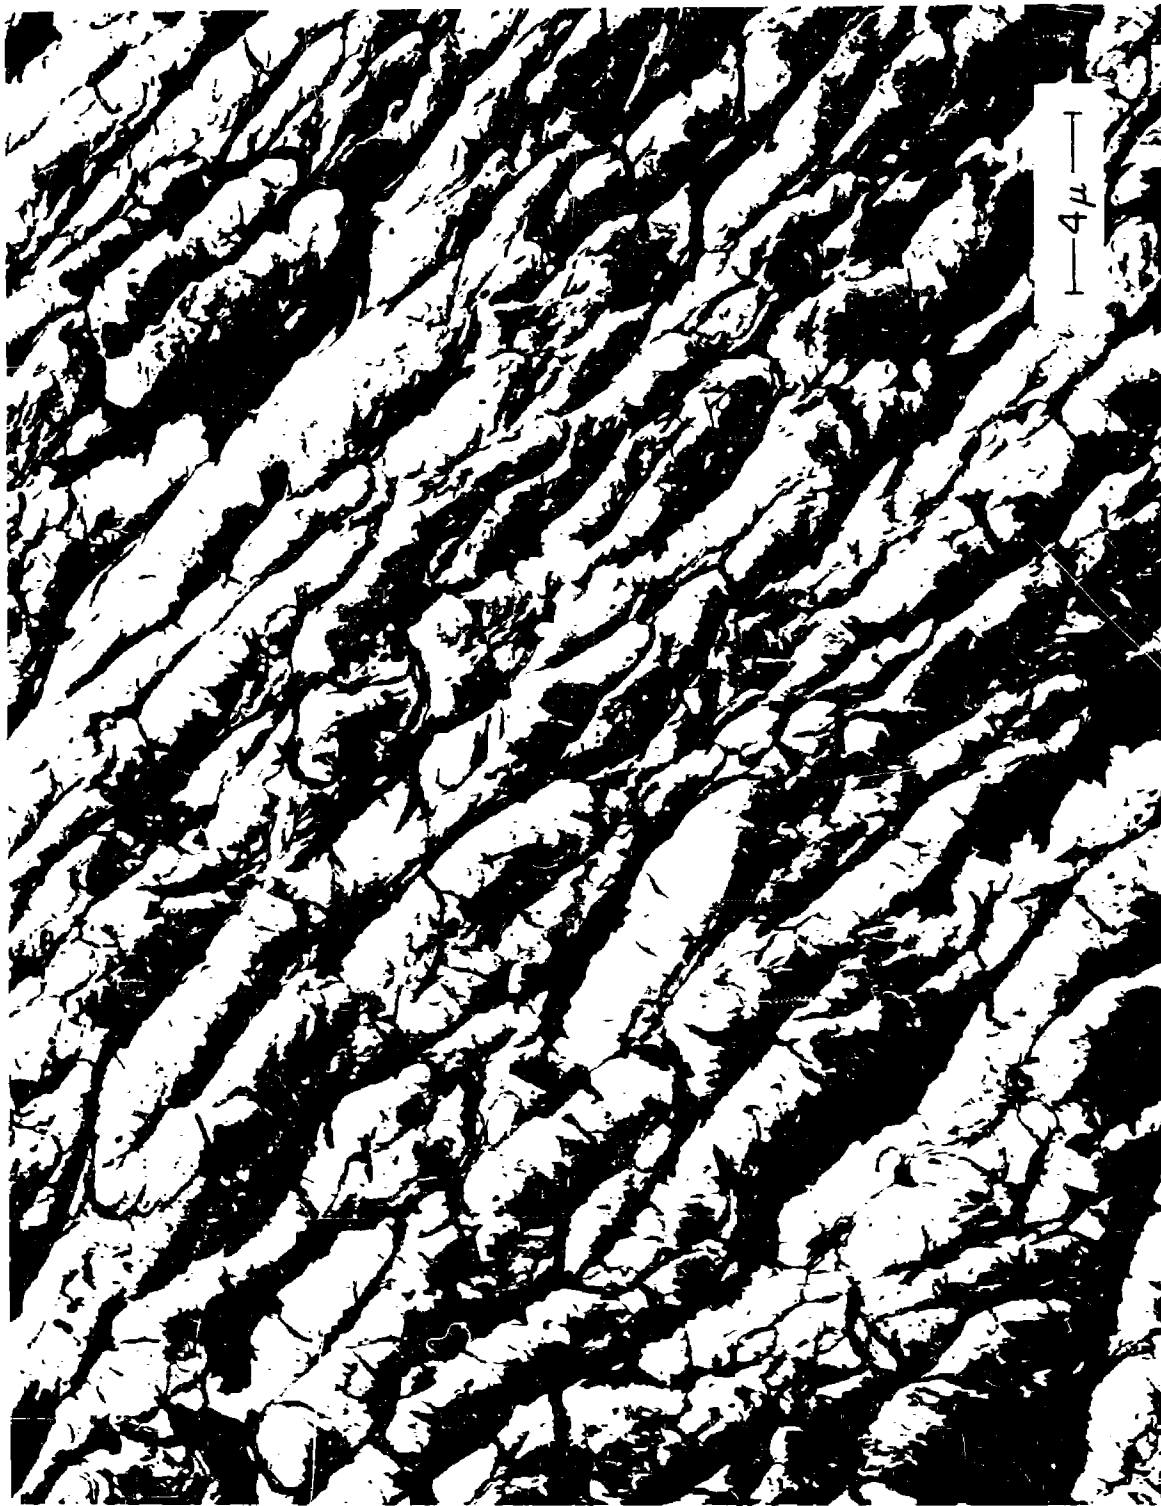
Fig. 3 - Artifact structure which developed when a plastic replica was removed from a polished and etched surface before drying completely

cellulose acetate, which is softened in acetone and moulded against the fracture. is removed before it has hardened sufficiently, it will pull away from the fracture unevenly and greatly distort the replica. The numerous finger-like protrusions shown in Figure 3 resulted from premature stripping of soft cellulose acetate.

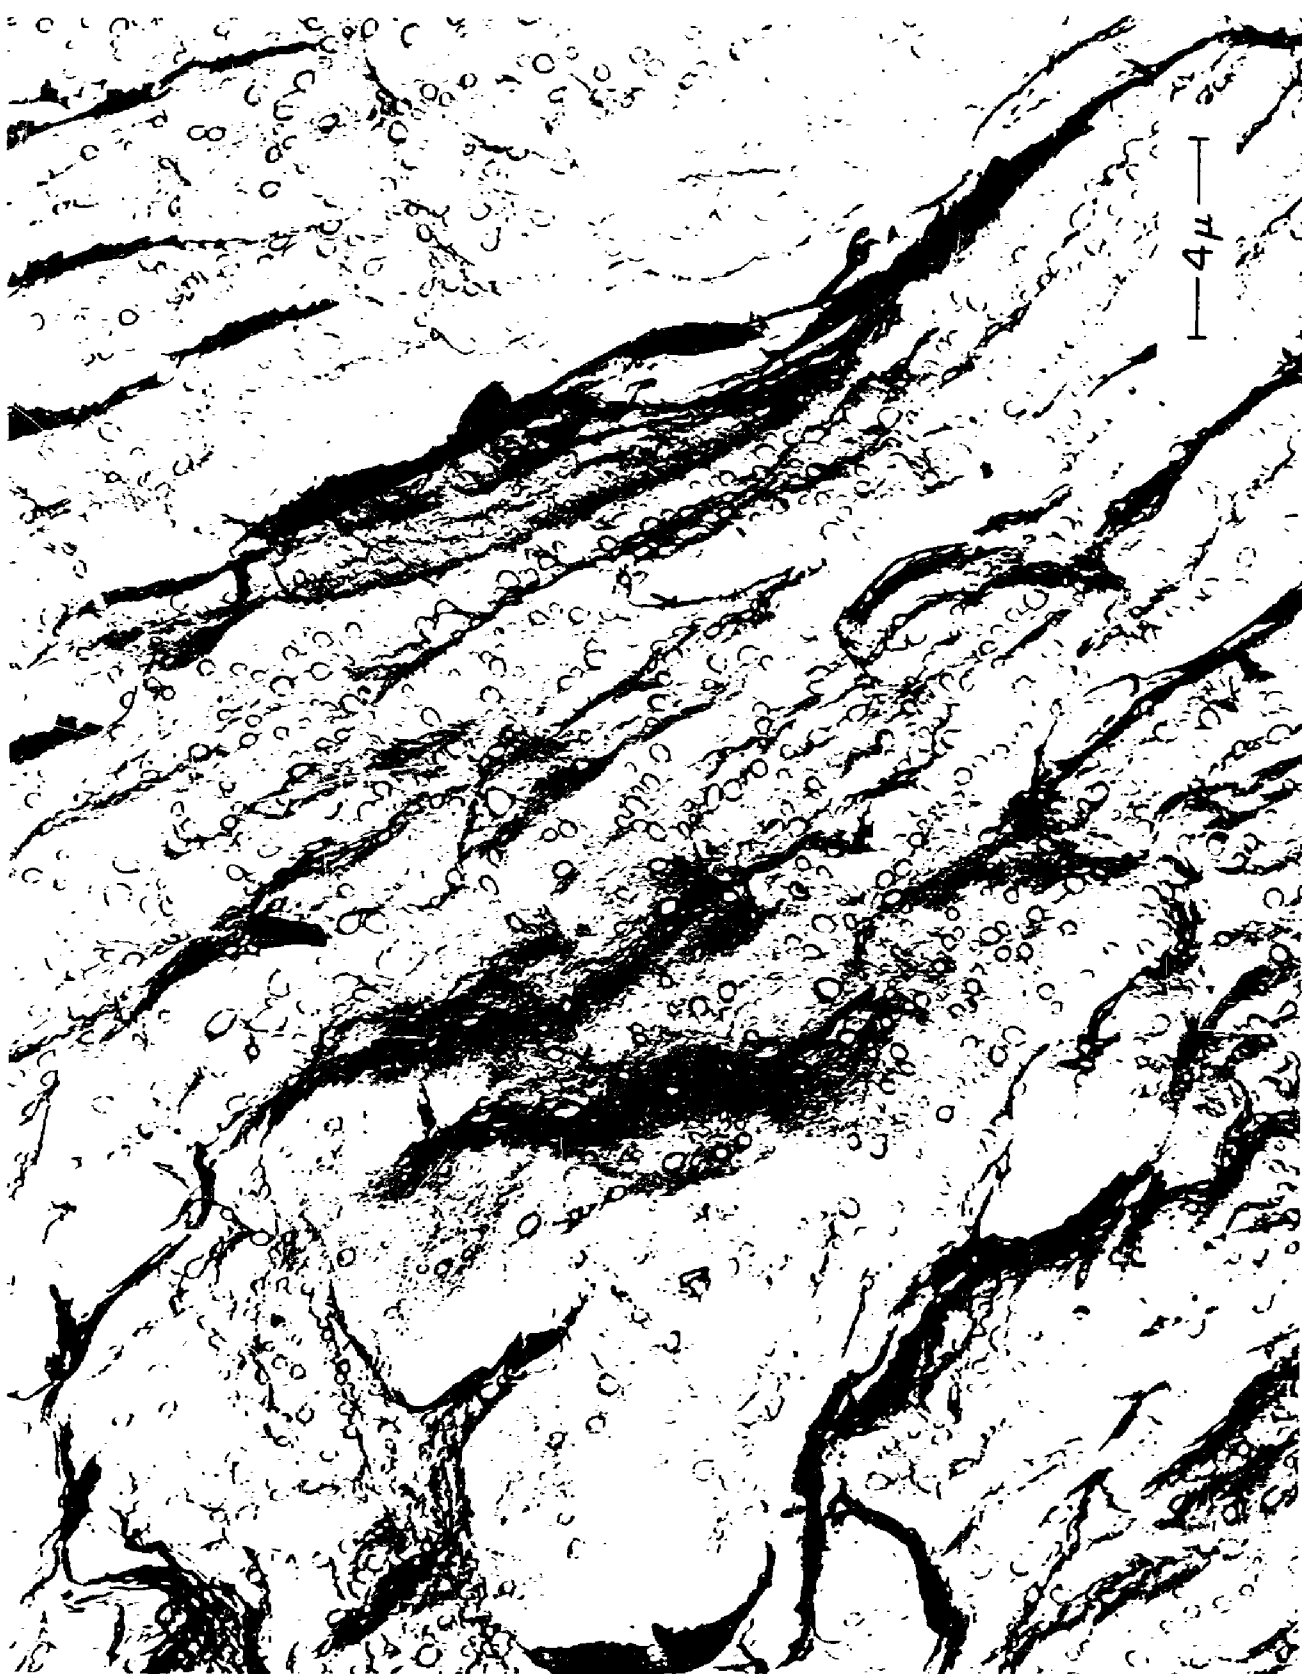
Fig. 4 - Bubble artifacts observed on a fatigue fracture replicated with a 10% solution of parlodion in amyl acetate

In several instances the use of a highly concentrated solution of parlodian in amyl-acetate for primary replicas resulted in artifacts of the type shown in Figure 4. The bubble-like artifact is thought to be associated with moisture which dissolves in the thick replication liquid. Generally the bubbles develop randomly over the entire surface but, in some cases, they concentrate along particular features of the fracture such as fatigue striations or cleavage tear lines. The bubbles develop in the liquid replicating solution just above the fracture surface, leaving a thin plastic layer between the metal and the bubble. Figure 5 shows an area in which this thin film has been partially or completely torn away.

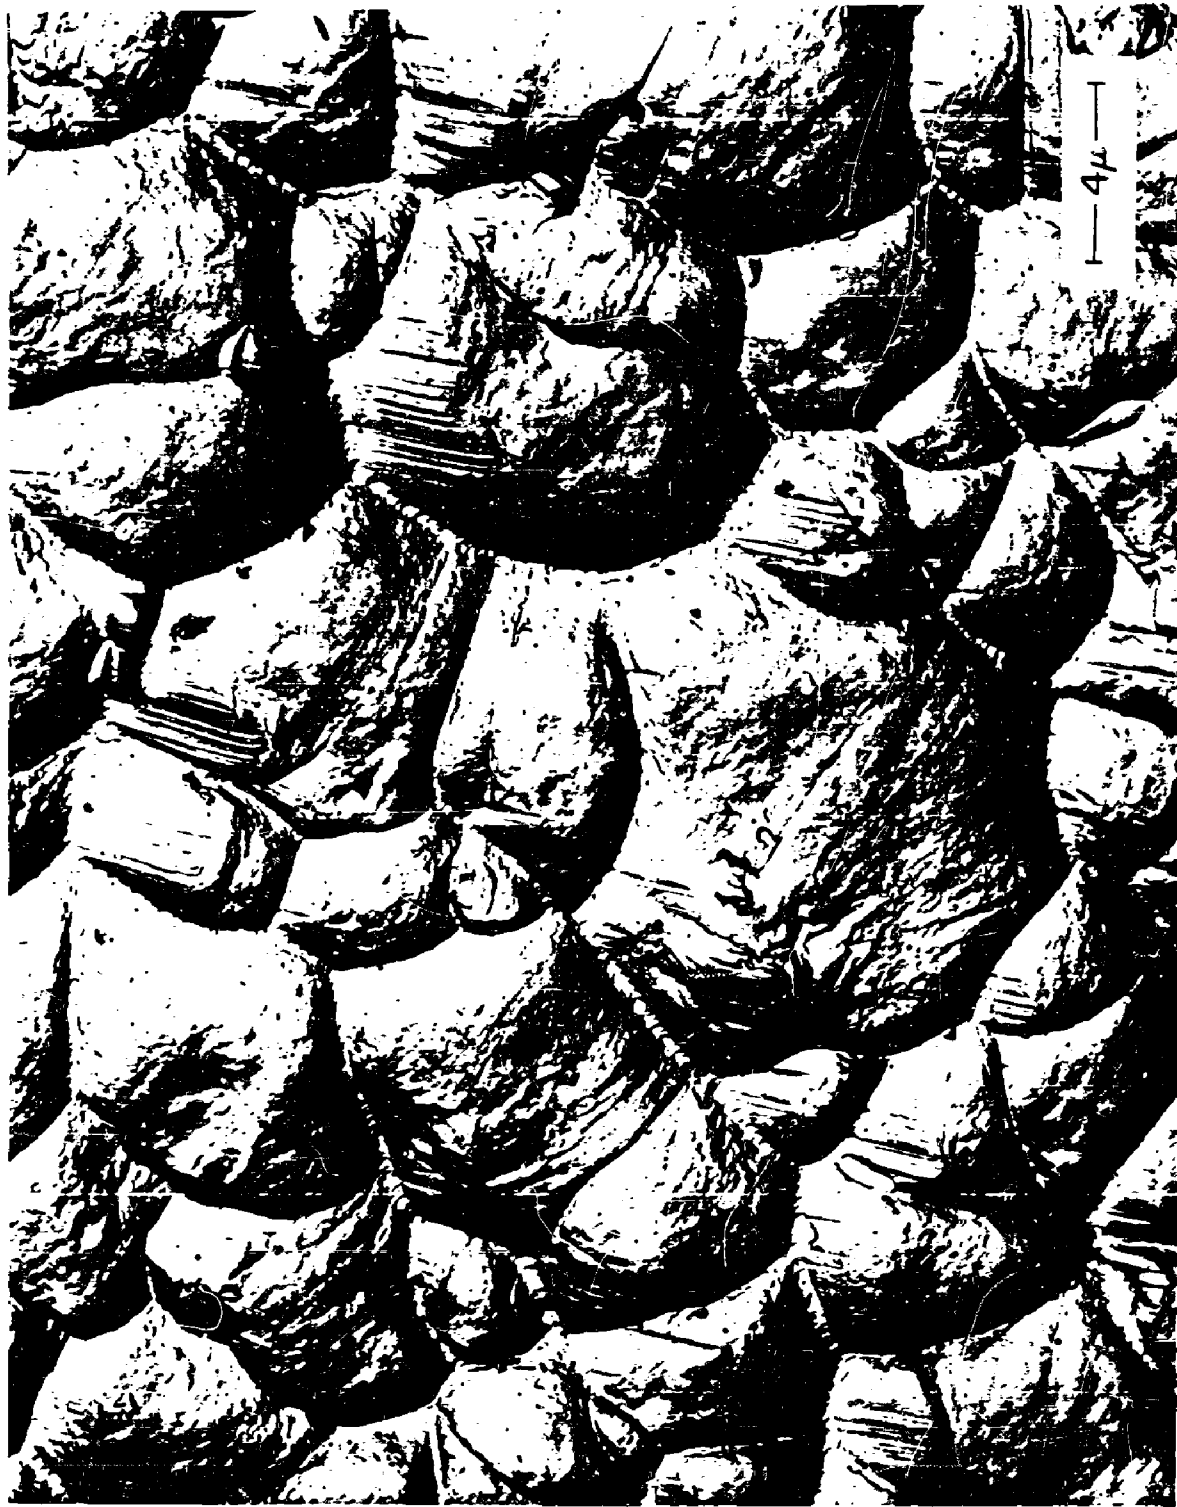
Fig. 7 - Artifact structure developed on the sides of rupture dimples due to scraping plastic replica against fracture face

Another artifact which may be produced during the plastic stripping operation is shown on the sides of rupture dimples in Figure 7. The parallel lines are formed when part of the plastic replica scrapes against the fracture surface during the stripping operation. The lines, which are generally uniformly spaced are observed on sides of hills or on slopes between elevation differences in the replica. The particular geometry necessary for scraping the plastic against the fracture is satisfied for these configurations. Figure 8 shows a precisely matched area on both halves of a fracture surface. The scraping artifact appeared on only one-half of the surface. This artifact is of special significance since it so closely resembles the characteristic striation topography of fatigue striations.

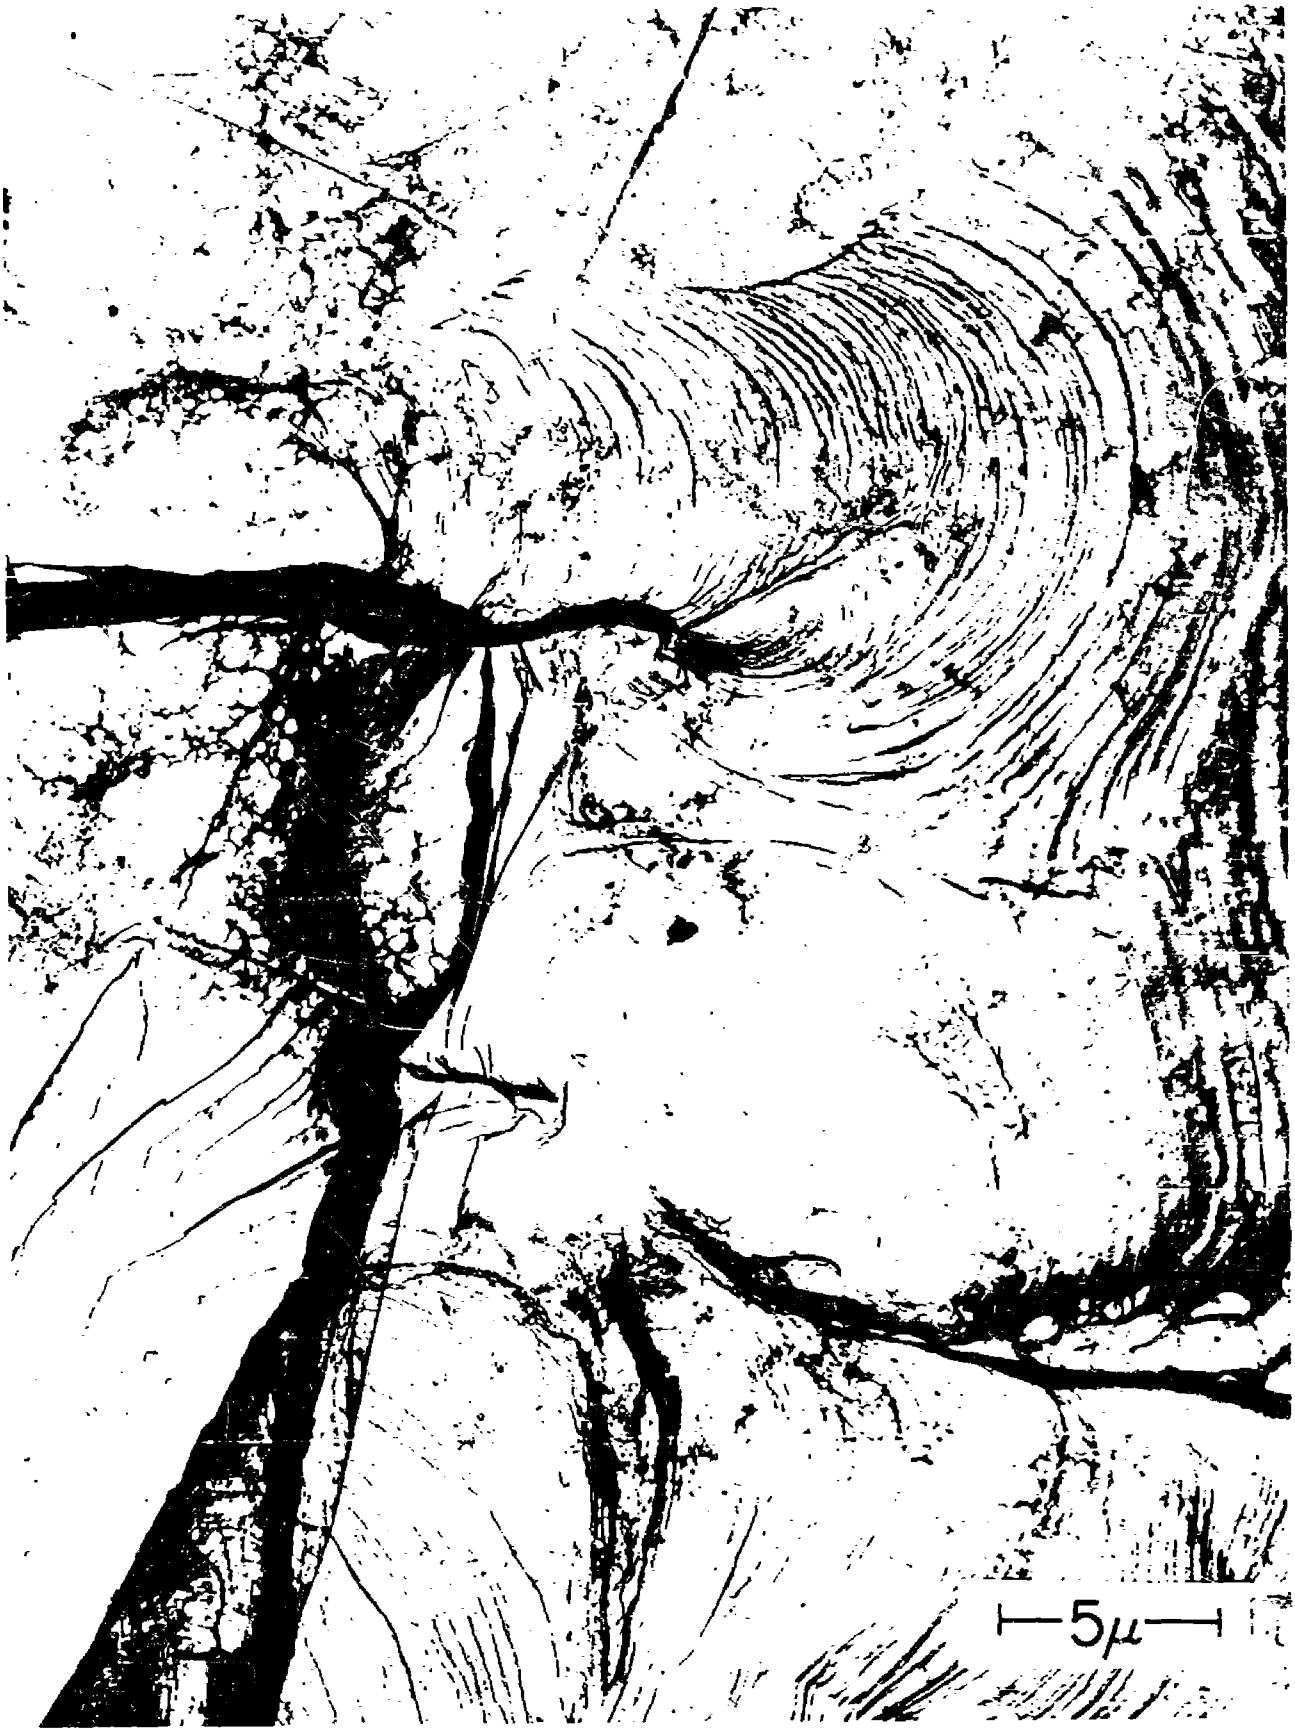
Fig. 9 - Undissolved plastic on final carbon replica

Figure 9 shows the appearance of undissolved plastic which has not been completely removed from the final carbon replica.

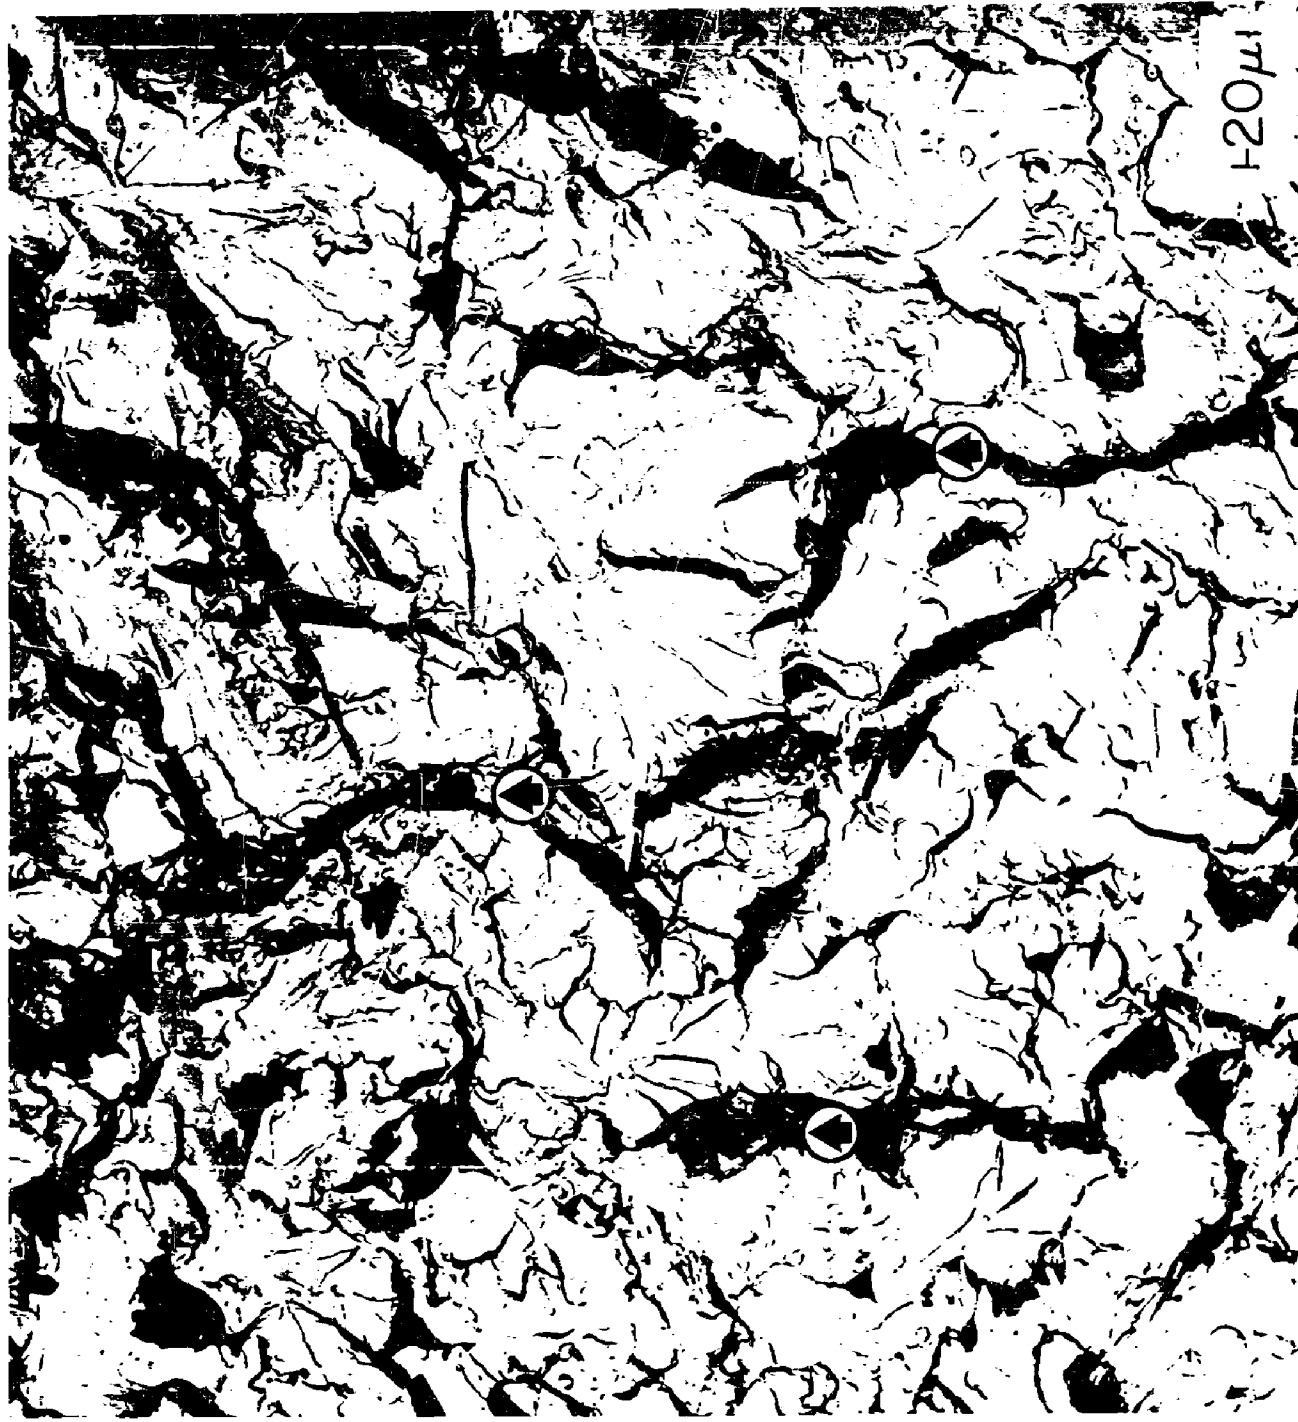
Fig. 11 - Collapsed carbon films (arrows) on replica of
cleavage fracture in mild steel

The final carbon replica is prone to tears and folds since it is very thin and fragile. The number of artifacts of this type, illustrated in Figure 10, can be reduced considerably by careful preparation and handling techniques. The collapse of carbon replicas on areas with abrupt changes in elevation cannot, however, be avoided by techniques available today. Figure 11 shows areas where the carbon replica

has collapsed in regions between cleavage facets on a fracture surface of mild steel.

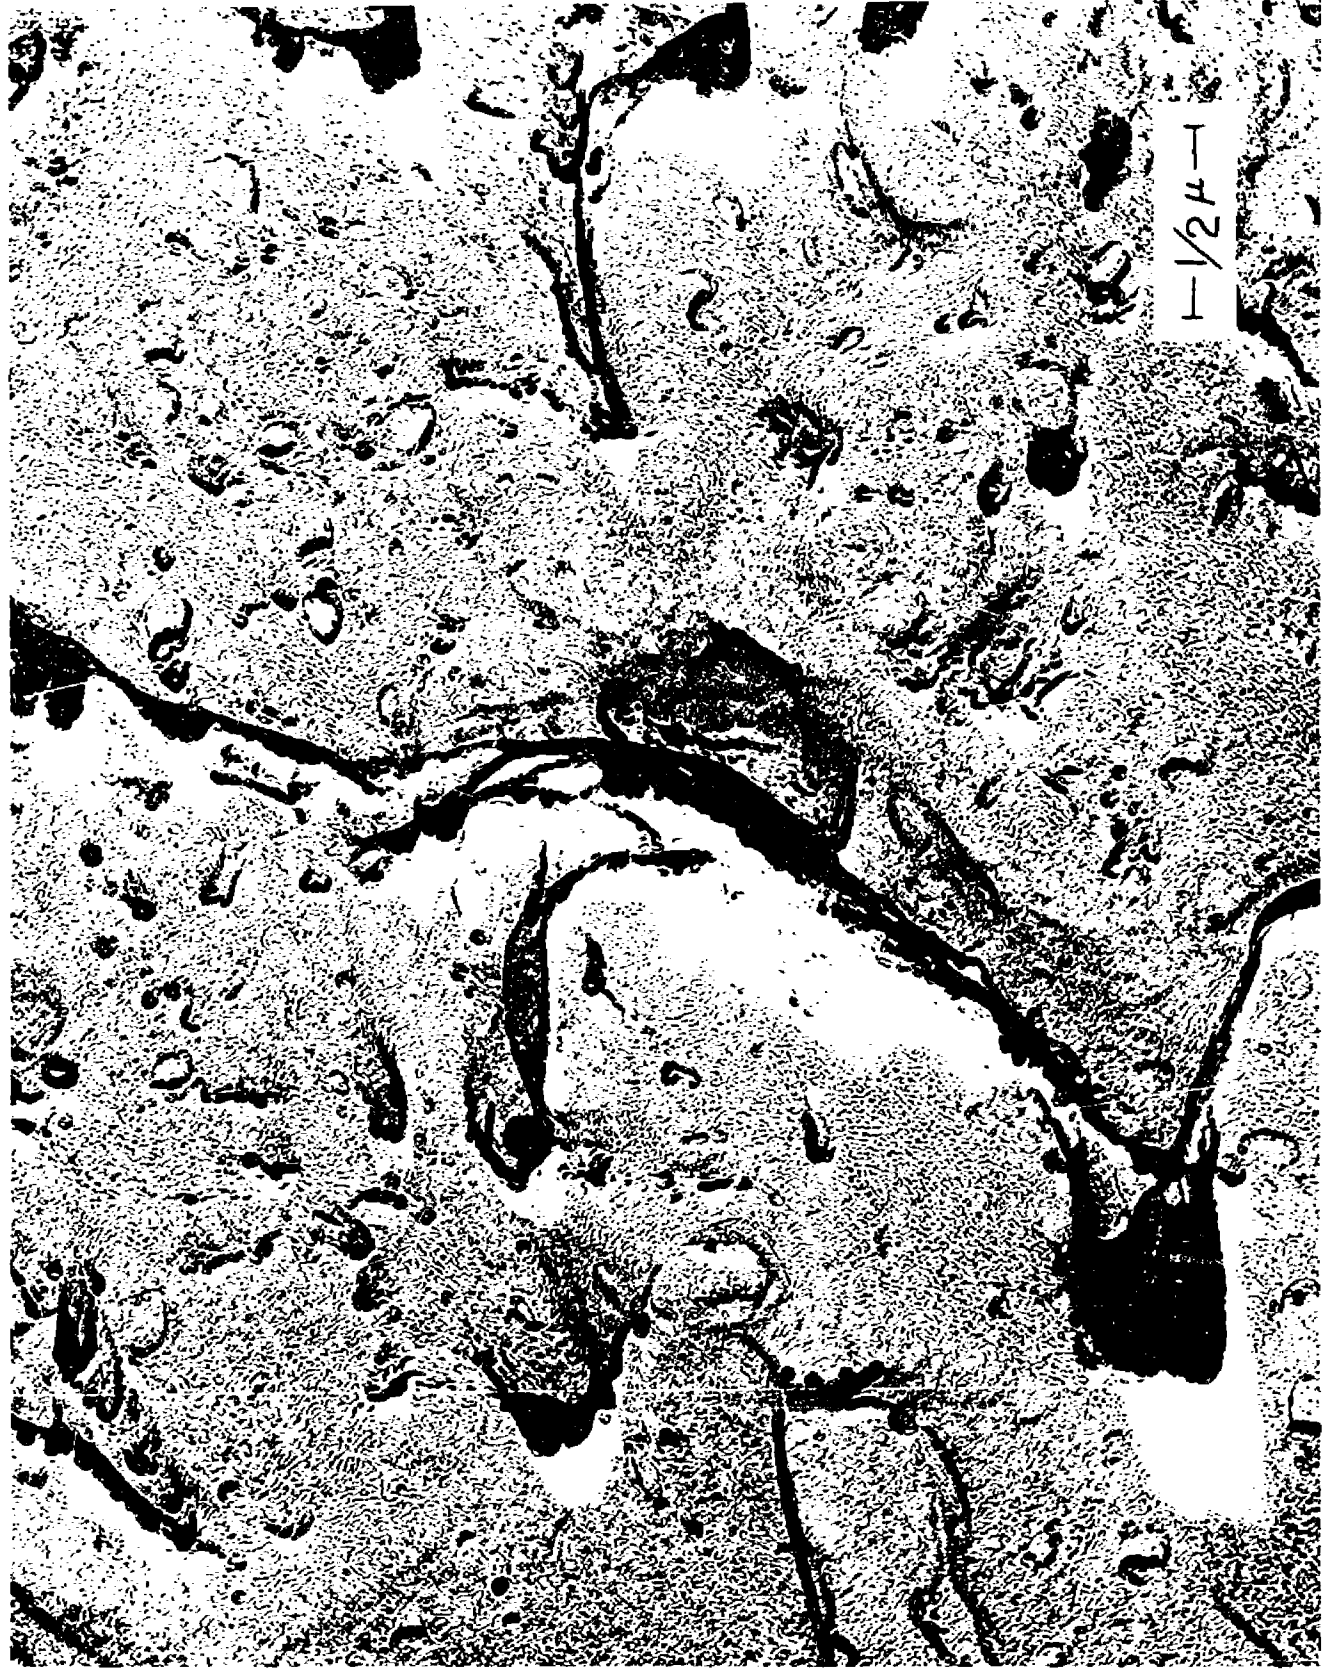
Fig. 12 - Granulated palladium shadowing material caused
by overheating carbon replica in electron beam

Overheating shadowed carbon replicas during observation in the electron microscope can cause the heavy metal shadowing material to coalesce. Figure 12 shows the granular appearance of this artifact.
